Use Attainability Analysis

WBID 3188 North Fork Spring River

Submitted by Golden City Wastewater Department

Use Attainability Analysis North Fork Spring Rive (Muddy Creek)

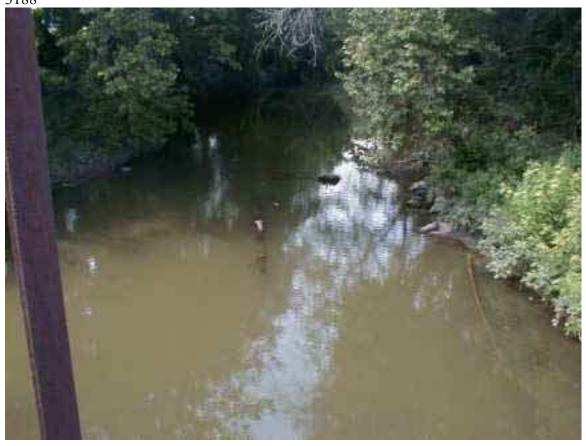
Picture # 1

An upstream view of Muddy Creek (location 37.40720 N; 94.08221 W)

This view shows logs resting on the bottom, steep slopes with heavy vegetation to the waters surface make it difficult to get to the water. Large rocks, mud and clay make up the bottom of this portion of the creek, with algae growth on approximately 50% of the creek bottom. Maximum run depth measured 2 feet.

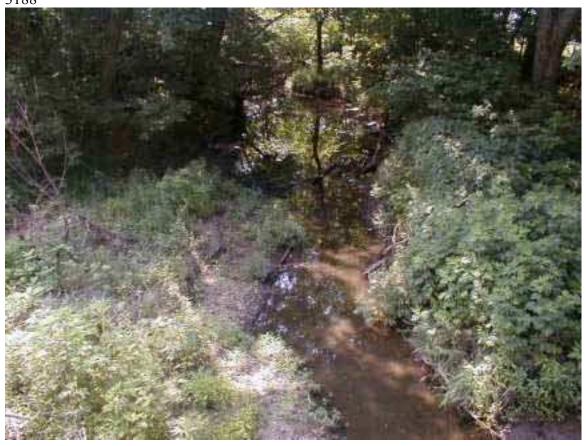
Picture #3

A upstream view of this east fork at this site (location 37.42934 N; 94.09111 W)

This view shows heavy vegetation along the banks. Maximum run depth measured 1 foot. This area has a gravel bottom with a gravel bar visible. Logs rest on the bottom, the run is connected by riffle, and algae growth is estimated at 50% on the bottom. No human use was observed except the bridge. Flow is estimated at .25 cubic feet per second.

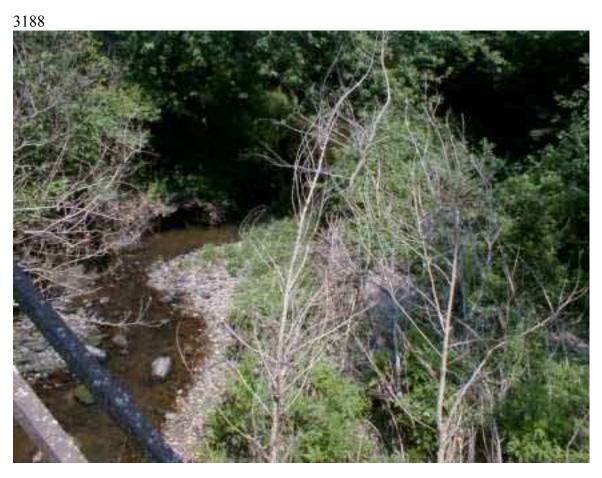
Picture # 4

Downstream view of the east fork at this site (location, 37.42969 N; 94.09153 W)

This view shows a long narrow run, very few riffles, large rocks, and gravel make up 80% of the bottom, with algae growth estimated at 50% on the bottom. Heavy vegetation along the banks make it very difficult to get to the creek. No human use was observed. Flow is estimated at .25 cubic feet per second.

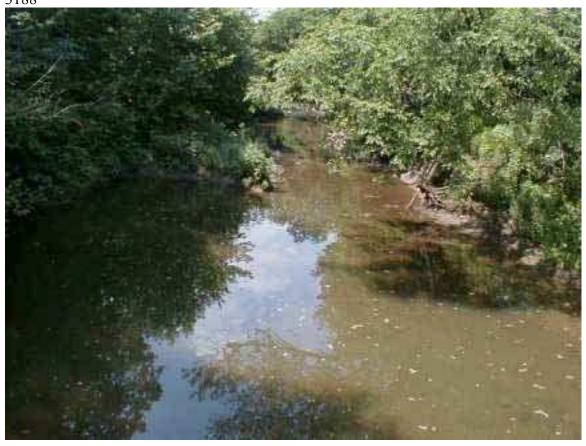
Picture # 5

Upstream view of the west fork at this site (location 37.42943 N; 94.09361 W)

This view shows a wider run than the east fork. You can also see the rocks on the bottom. You can also see that the banks are steep and are lined with heavy vegetation making entrance to the creek difficult, maximum depth measured 1 foot. No human use was observed at this location. Algae growth is estimated at 50% on the bottom and flow is estimated at .25 cubic feet per second.

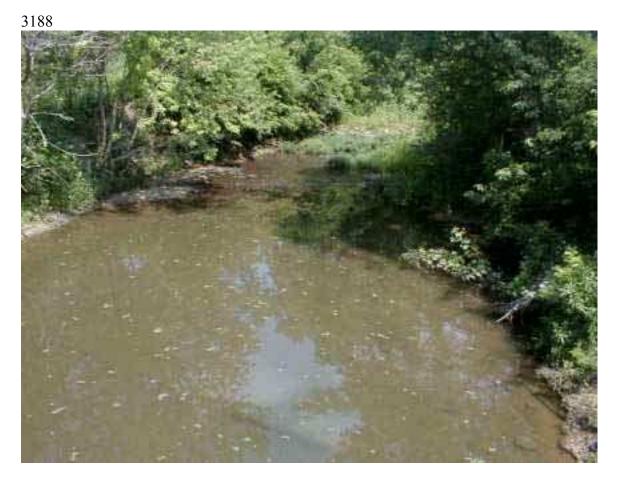
Picture # 6

Downstream view of the west fork at this site (location, 37.42948 N; 94.09632 W)

This view shows a pool that ends with riffle. Maximum depth measured 1 foot, heavy vegetation along the banks makes it difficult to get to the creek. No human use was observed at this site, and algae growth is estimated at 50% on the bottom. Flow is estimated at .25 cubic feet per second.

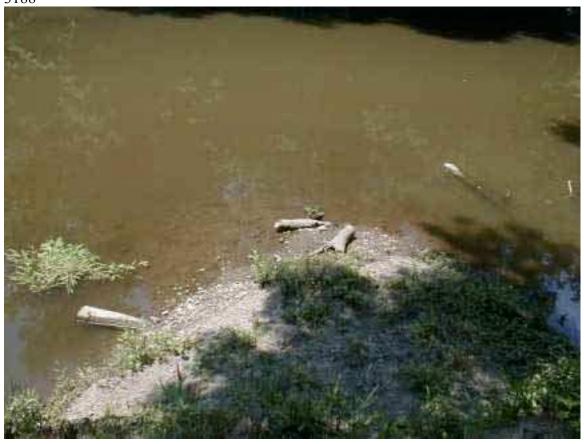
Picture # 7

This view is upstream of site #3 3188-003 about ¼ mile. The landowner along the east side of the creek uses this area for fishing and camping only. As you can see there are logs and large trees that rest on the bottom, maximum depth in this area is estimated at 3 feet. The landowner has carved holes in the steep bank to make access easier. Flow was estimated at .25 cubic feet per second.

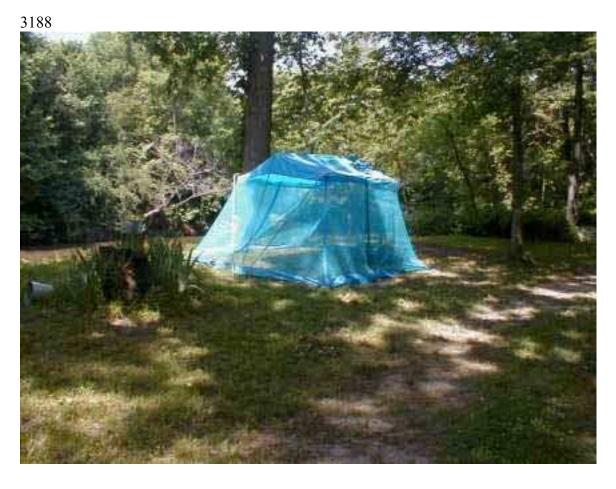
Picture #8

This view is the camp area of the same location as picture # 7. As you can see it is maintained very well to help control the insects. He does allow some visitors to fish and camp, but recommends no swimming.

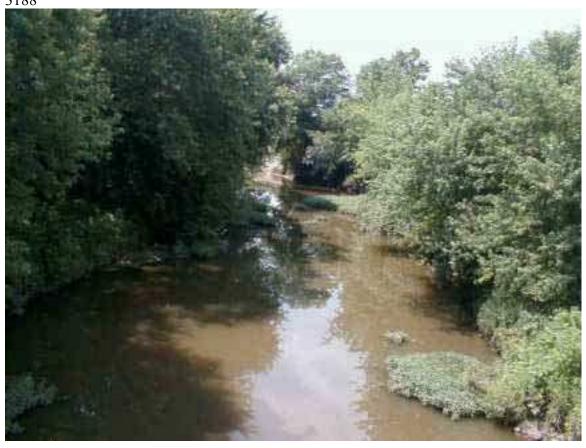
Picture #9

A upstream view at this site (location 37.45107 N; 94.12399 W)

This view shows very heavy vegetation along the steep banks, but access to the creek can be made at the bridge. Maximum depth was measured at 2 feet. Flow is estimated at .25 cubic feet per second. Algae growth was estimated at 50% on the bottom.

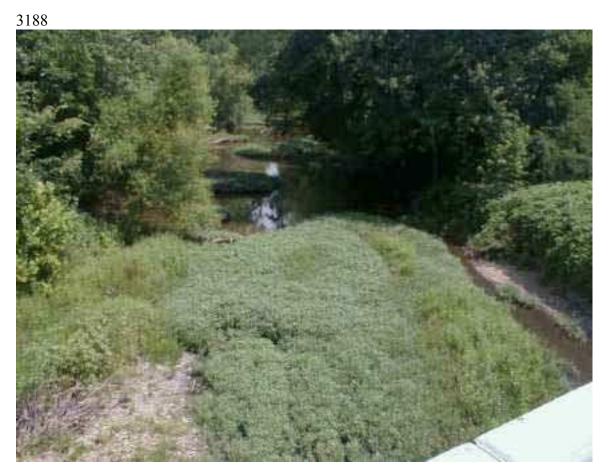
Picture # 10

A downstream view at this site (location 37.45306 N; 94.12289 W)

This view shows very heavy vegetation on the creek bottom as well as along the banks, making access difficult there but access can be made at the bridge. Maximum depth was measured at 2 feet. Flow was estimated at .25 cubic feet per second. Algae growth in the bottom was estimated at 50%. No human use was observed.
